Manhole Inspection Summary

Manhole # S08II2007MH

Insp Date: **9/25/06 3:25 PM**

Location Address: **7406 PARK HEIGHTS AVE**

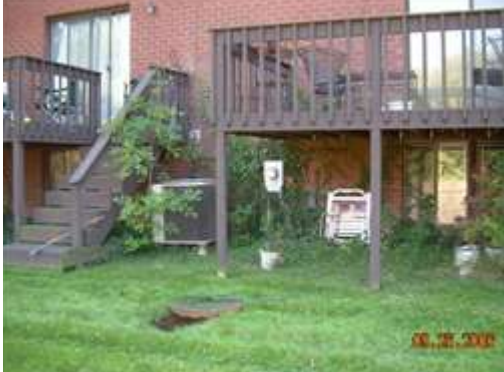
Location View

Comments **County MH lid.**

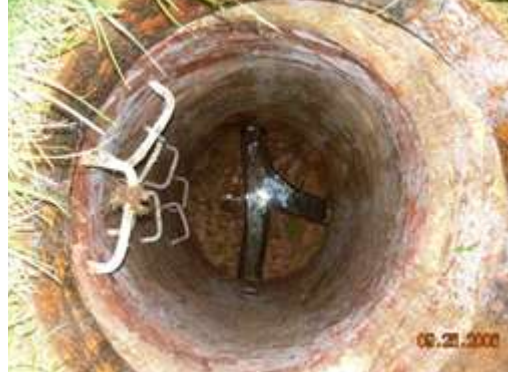
Top View

Corbel and Barrel. Evidence of surcharge - Bench debris. Channel debris.

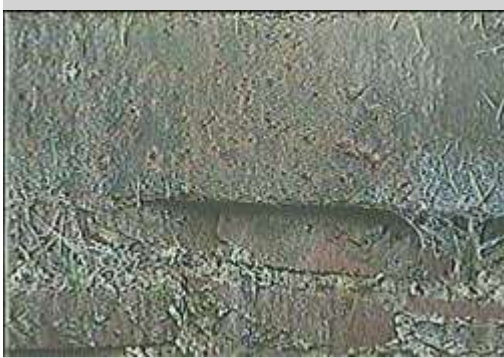
Defect

☒ **Leaks**

Condition: ☐ Sound ☐ Cracked ☐ Root Intrusion ☐ Loose Brick ☒ **Deteriorated**

Infiltration: ☐ None ☒ **Joint** ☐ Cracks ☒ **Mortar** ☐ Roots ☐ Wall

Frame leaks. Adjustment deterioration and infiltration.

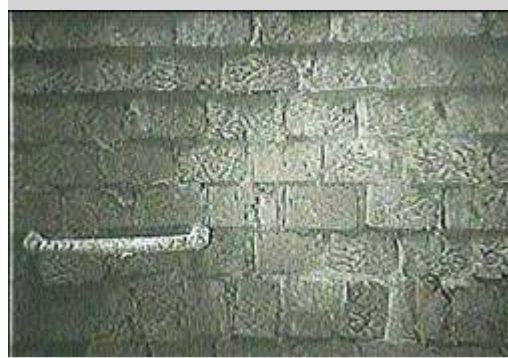
Defect

Condition: ☐ Sound ☐ Cracked ☐ Root Intrusion ☐ Loose Brick ☒ **Deteriorated**

Infiltration: ☐ None ☐ Joint ☐ Cracks ☒ **Mortar** ☐ Roots ☐ Wall

Barrel deterioration and infiltration.

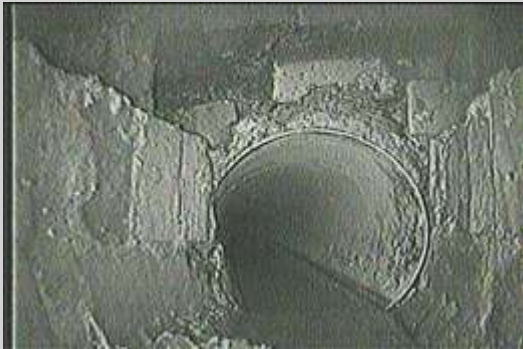
8 in. Circular Gravity Sewer Pipe Out @ 12 O'Clock

Infiltration: **None** Pipe Seal Cond: **Cracked**

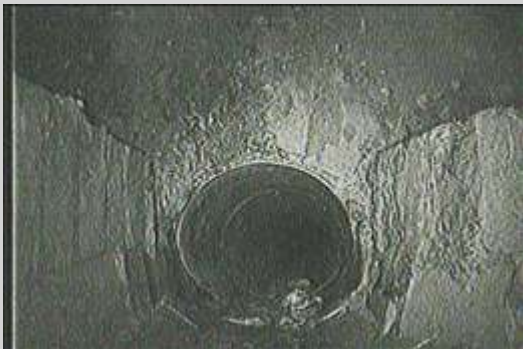
8 in. Circular Gravity Sewer Pipe In @ 3 O'Clock

Deposits: ☐ None ☐ Mud ☐ Sludge ☒ **Debris** ☐ Grease

Silt Depth: **0** (in.) Deposits Extent: **Light**

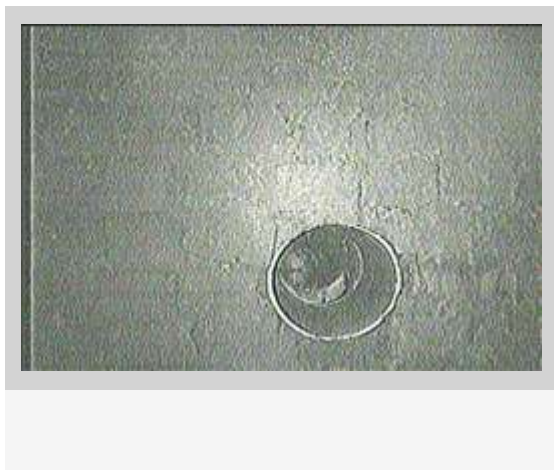
Pipe In @ 6 O'Clock

Deposits: ☐ None ☐ Mud ☐ Sludge ☒ **Debris** ☐ Grease

Infiltration: **Evidence**

Pipe Seal Cond: **Cracked**

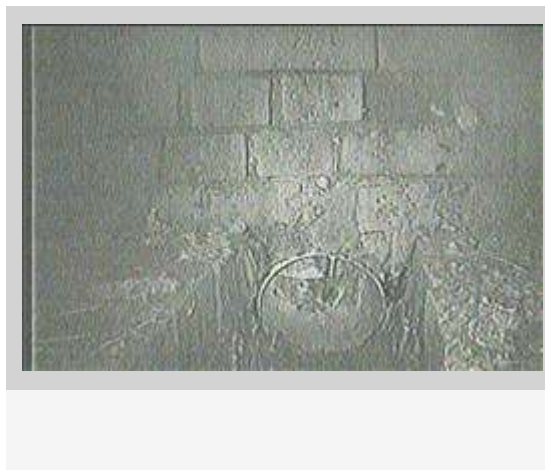
Drop In @ 6 O'Clock

Drop: **Outside** Rod and Bar

Drop Condition: **Open**
